## 2014 年 3 月 30 日湖北省秭归 M4.7 地震房屋震害特征分析<sup>①</sup>

**摘要:**2014 年 3 月 30 日湖北省秭归县发生 M4.7 地震,震中烈度Ⅵ度,地震对震中区的房屋造成了不同程度的损坏。通过对震中区房屋震害情况进行抽样统计和分析,归纳总结了农村两种常见类型房屋的典型震害特征,并对其原因进行深入的分析。在此基础上,对农村民居的场地选择及设计施工等提出一些建议,可以为灾区及其他抗震设防地区的农居建设及政府决策提供依据和参考。

## Building Damage Characteristics during the Zigui, Hubei M4.7 Earthquake on March 30, 2014

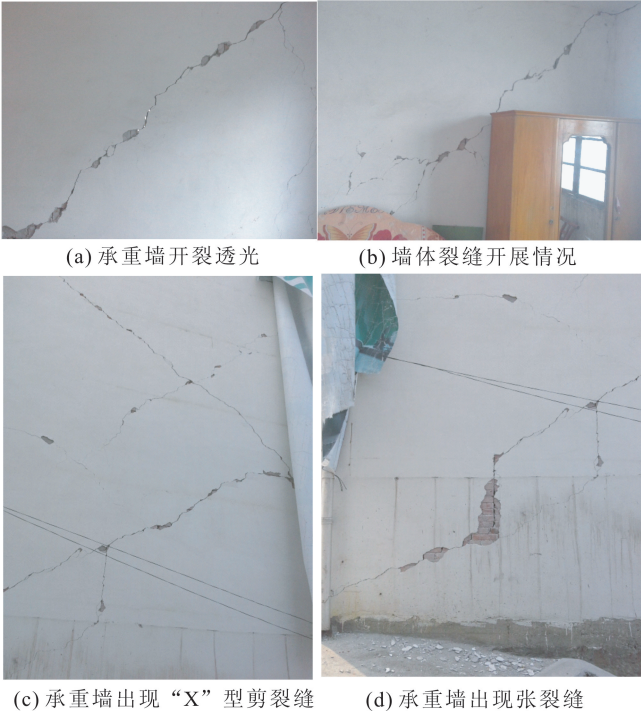
墙体破坏在此次地震中普遍存在,主要表现为裂缝。在当地民居中,外墙多采用空斗墙,薄弱的墙体因抗剪强度不足而产生斜裂缝,在往复地震作用下将进一步形成“X”型张裂缝(图 4)。

图 4 震中区砖混结构房屋的墙体开裂现象  
Fig.4 Walls cracking of brick-concrete buildings in epicenter area

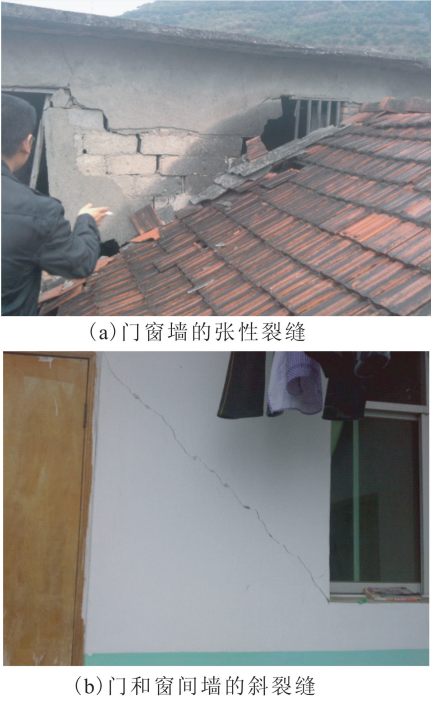
在建造农村房屋时,人们片面地追求大开窗,大窗户洞口的设置使墙体的横截面积突然减小。在地震作用下,墙体受到的剪力一旦超过墙体的抗剪强度,就会产生水平裂缝和竖向裂缝甚至交叉裂缝(图 5)。

图 5 震中区砖混结构房屋的门窗间墙破坏  
Fig.5 Damage of walls between door and window of concrete-brick buildings in epicenter area

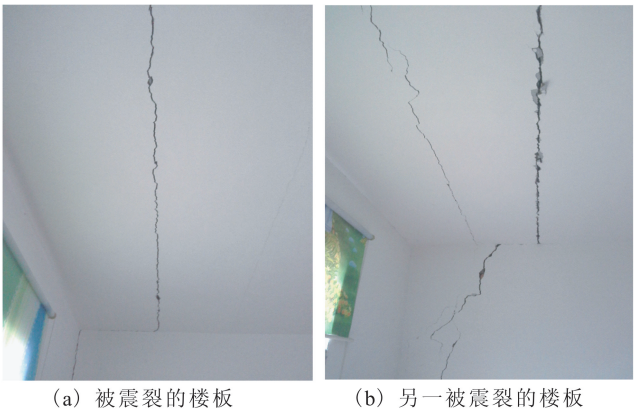
在鄂西农村民居中,早期建设的房屋多采用预制楼板做楼面。由于预制楼板与墙体连接不牢靠或搁置长度不够,均容易在地震作用下导致震裂(图 6),严重的甚至错位、掉落。

图 6 震中区砖混结构房屋楼盖破坏现象  
Fig.6 Damage of floors of concrete-brick buildings in epicenter area  
现为瓦片掉落、墙体开裂和坍塌(图 7)等。这种建筑建造工艺粗糙,没有构造措施或构造措施不齐全,墙厚也不符合要求,房屋的整体性较差。农民自建土木结构房屋时,屋面的大梁与纵墙或横墙没有可靠的锚固措施,地震时容易发生墙体倾斜而导致屋架塌落。

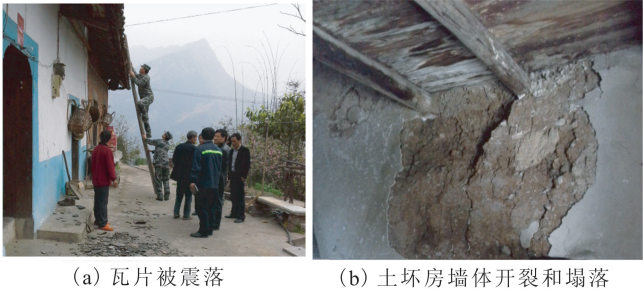
土木结构房屋建造工艺简单,通常就地取材,且造价低廉,在偏远农村自建房屋中比较常见。这类房屋多为土墙承重,屋盖采用木结构。在本次调查的土木结构房屋中,多数年代较为久远。在此次地震中,土木结构房屋的震害主要表

图 7 震中区土木结构房屋的震害现象  
Fig.7 Damage of civil buildings in epicenter area
